TS-AMD-88089b  
June 1984

# **AERIAL PHOTOGRAPHIC ANALYSIS OF OIL, CHEMICAL, AND INDUSTRIAL FACILITIES Los Angeles County, California Volume 2**

EPA Region 9

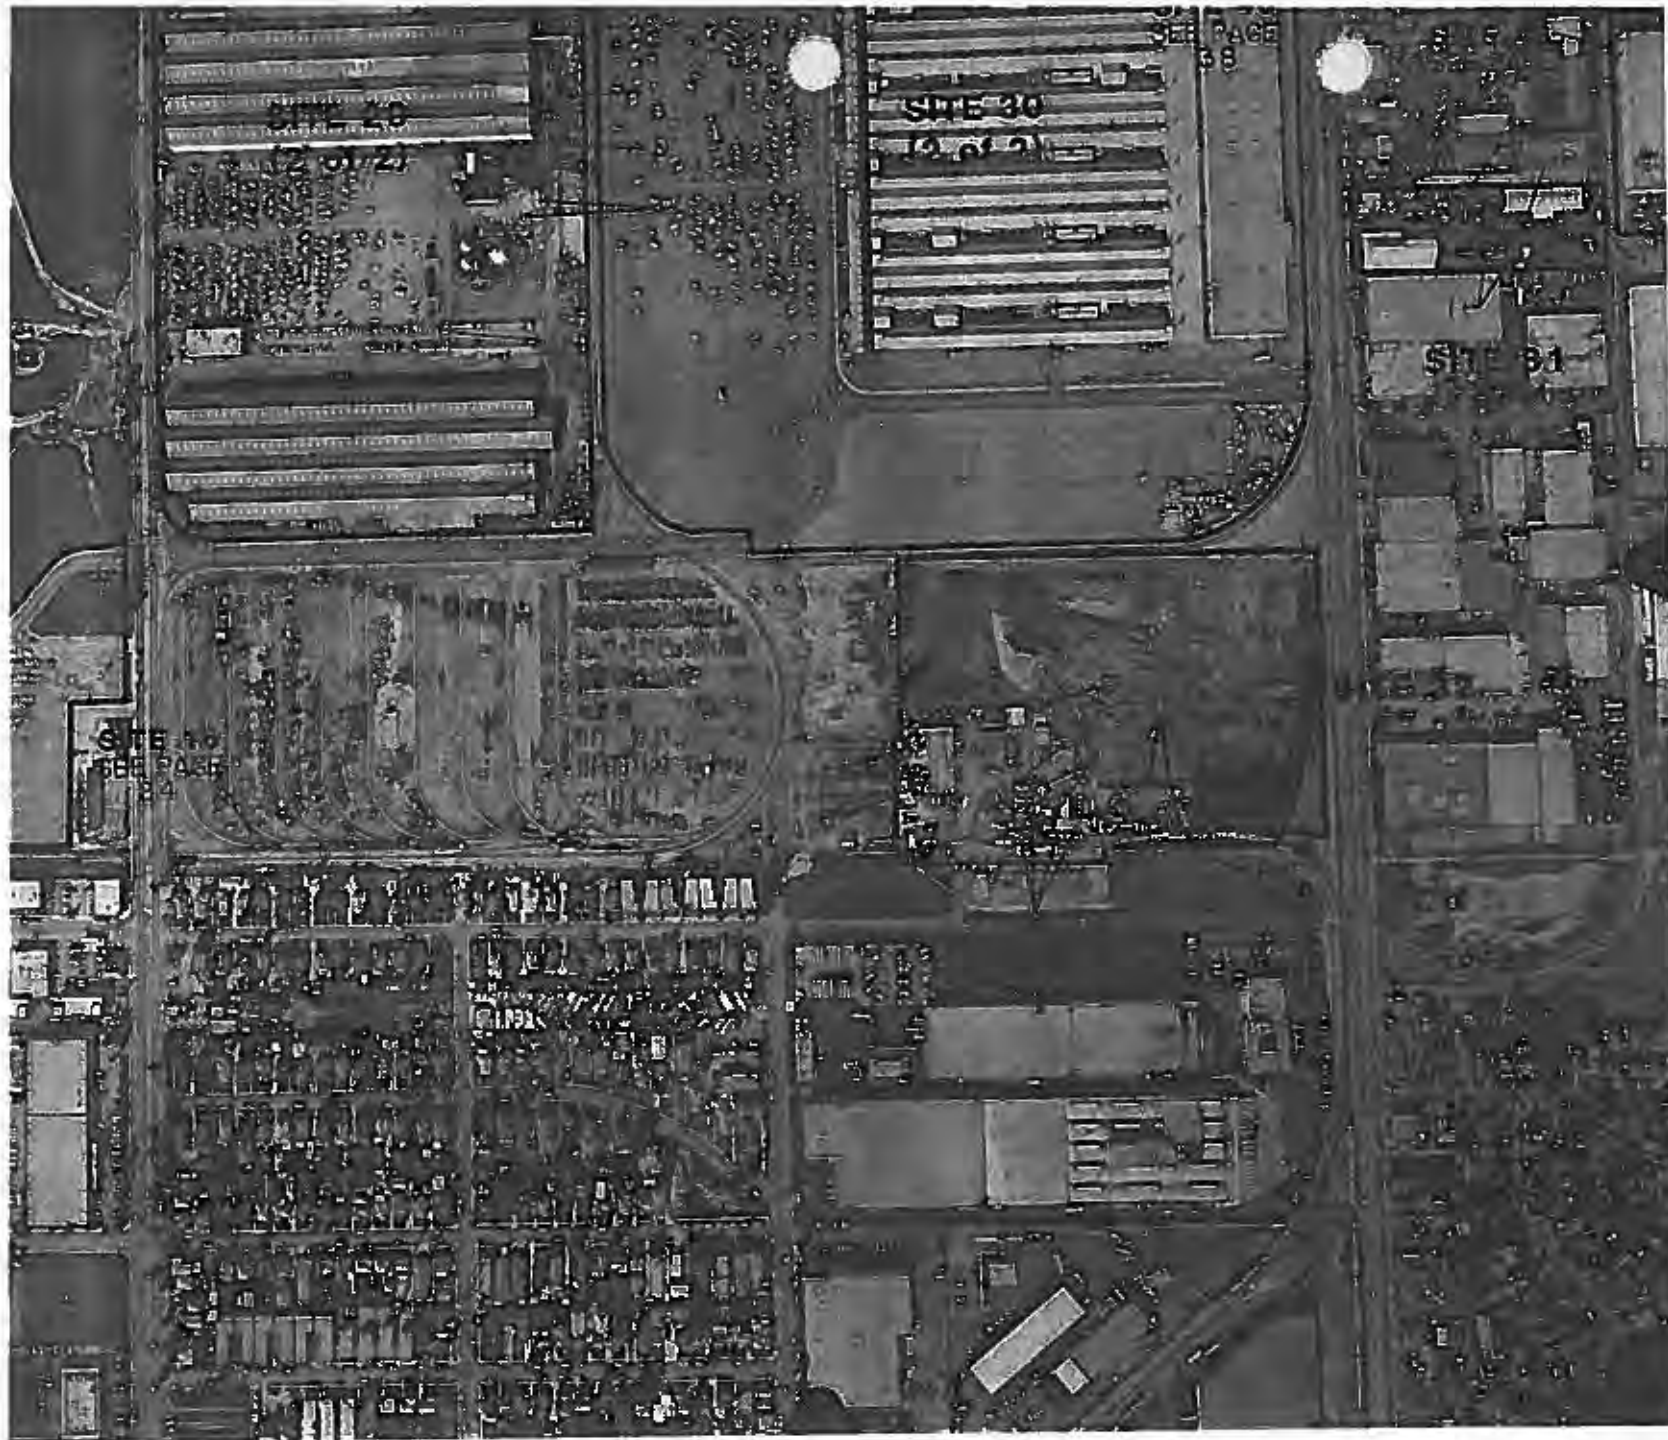
Figure 12. Sites 31 and 32, November 23, 1983. Approximate scale 1:6,000.

SITE 31 is a steel fabrication facility with three vertical and two horizontal tanks that lack secondary containment and two pressure tanks. Any spillage would exit the site and enter the storm sewer system.

SITE 32 is a chemical processing and supply facility with 27 vertical and 9 horizontal tanks that lack secondary containment, 5 vertical and 2 horizontal tanks that are adequately contained, extensive drum storage throughout the facility, 6 tank car loading racks, and 1 tank truck loading rack. Any spillage would enter an internal drainage system or collect in numerous depressions within the site.
